Why I always fly IFR

BY STEVE OLENSKY, MOBILE, ALABAMA

BONANZA BE35 1965 S-MODEL - N42AB
IO-520 engine with McCauley 3-blade prop,
approximately 1,450 hrs. since installed (REM)

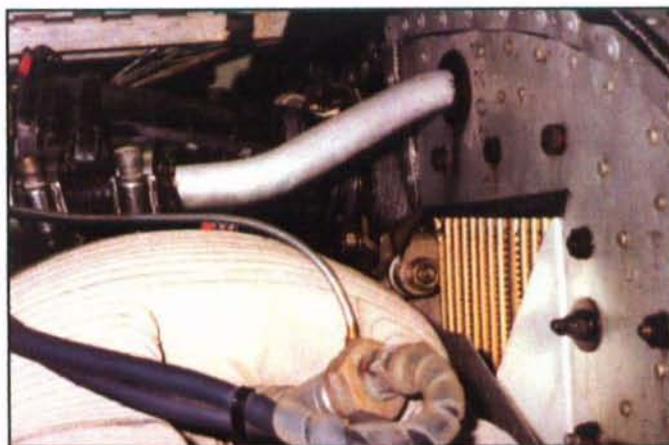
A closer look at the engine revealed a fist sized whole in the case above the back right cylinder. The left mag was dislodged from its mount and numerous clamps and straps were loose. Needless to say, the engine was trashed.

Loose mag with hole in case on left side.

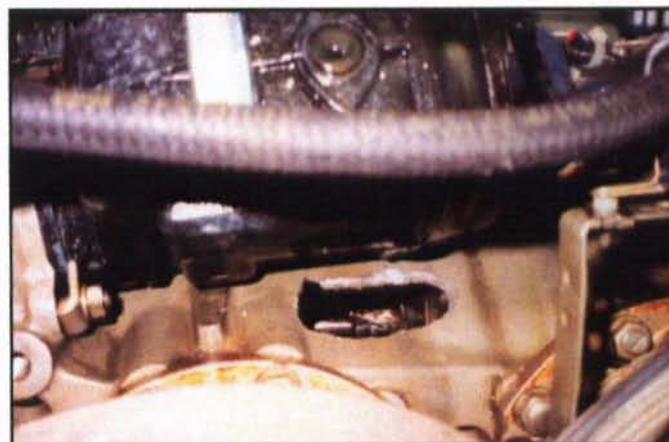
A quick look at the left side of the engine compartment revealed all of the fresh oil streaming along the entire left side of the plane. If only I could have seen this from the pilot's seat. I went into the FBO and called Flight Service to notify them that we were down and OK, and got with the local FBO folks to pull the plane off the runway to a tie-down spot. About this time, the paramedics, sheriff and local rescue personnel showed up. I thanked everyone for their concern and asked "Where the heck are we." We had made it to the Tri County Airport in Bonifay, Florida (1J0).

Hole on right side of engine.
